Re: Stone Durability Testing
Chicago Harbors Marina Project
WJE No. 2010.0683.0

Attachment A: Petrographic Examinations Prior to Freeze-Thaw Testing

Attachment B: Petrographic Examination after the Completion of Freeze-Thaw Cycling

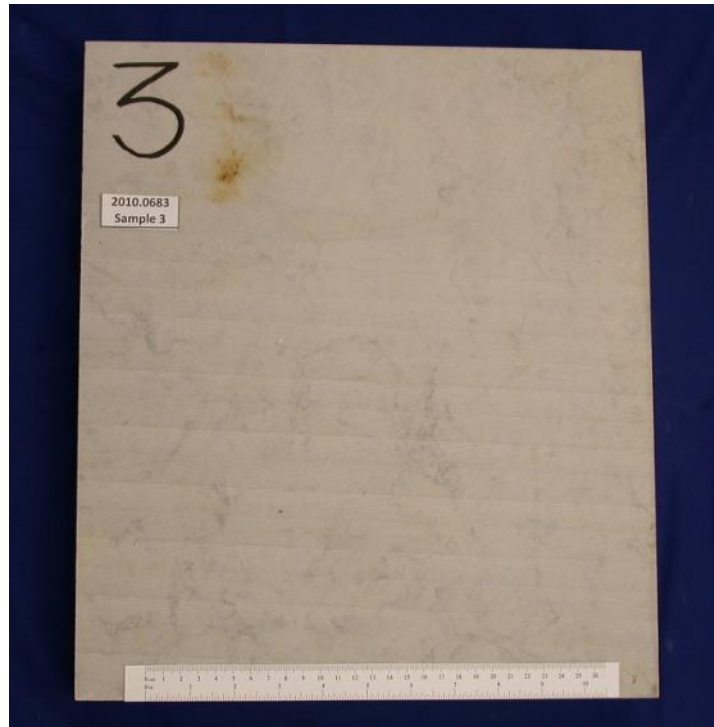
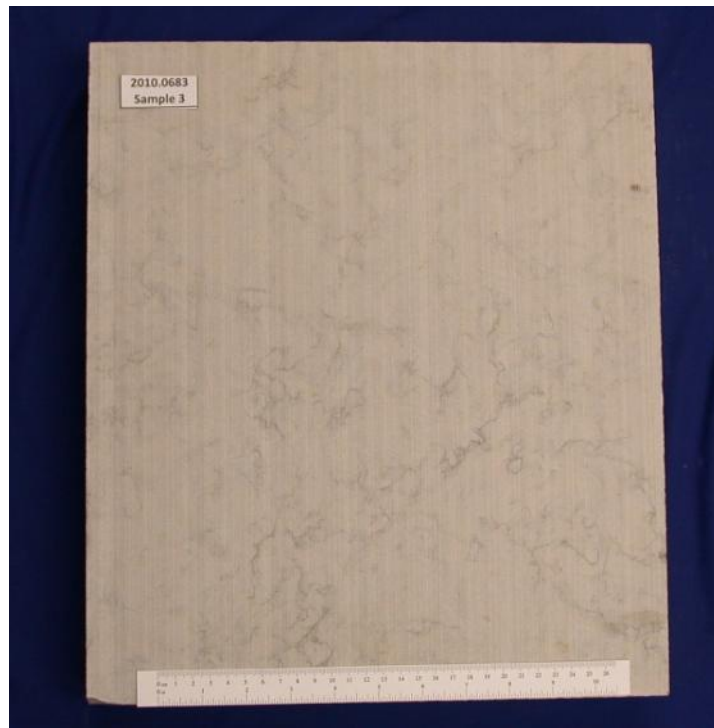
Figure 3. Front and back surface of Slab 3.

The stone does not contain prominent bedding planes. No fractures, veins, or stylolites were observed. The stone exhibits fine-scale porosity. No vugs or cavities were observed; however, Slabs 4 and 5 contain a small number of pores up to 0.04 inch in diameter scattered throughout the stone. Slab 3 had been chipped in one location along the back edge prior to examination. Small rust-colored spots and long streaks were observed on some surfaces, possibly caused by saw-cutting or sample handling. Stain-causing minerals such as pyrite were not observed. Chemically and physically unstable materials were not observed.

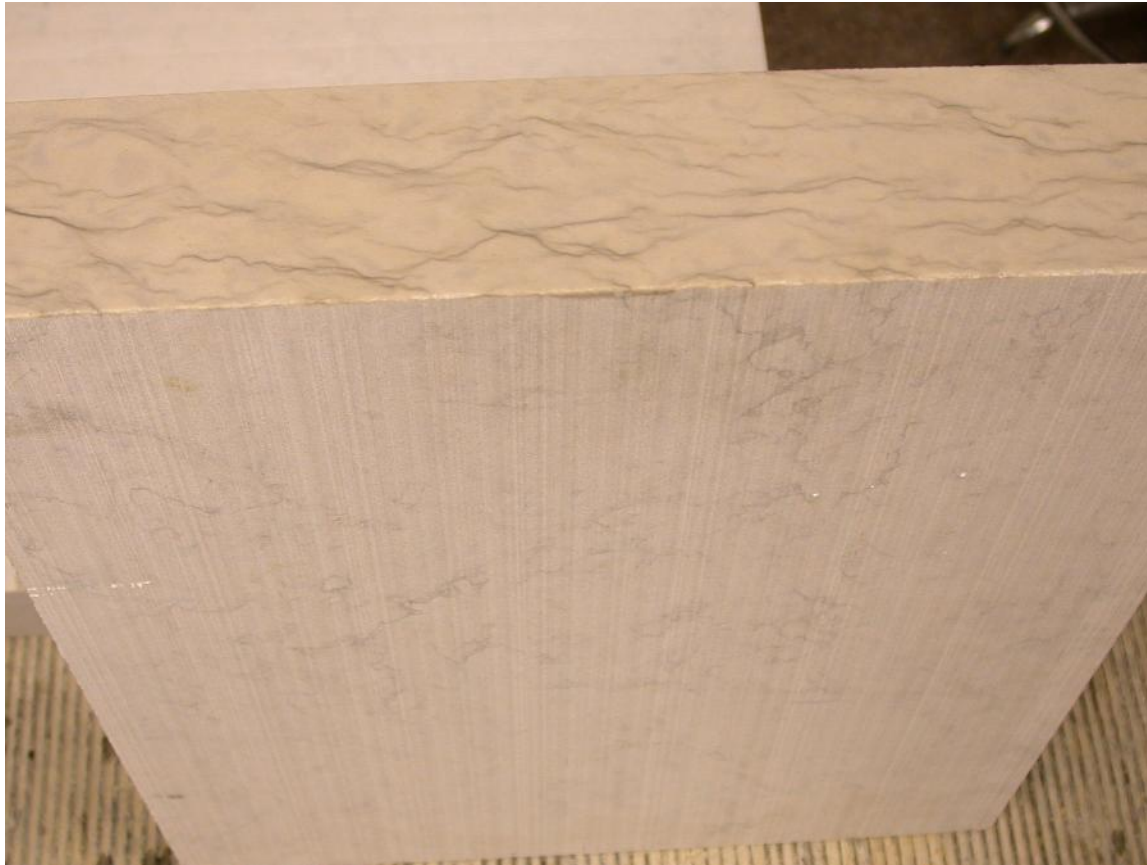
The stone is beige to beige-gray, fine-grained dolomitic limestone. All the specimens contain gray veining that typically occurs as feathery (diffuse), sub-parallel veins up to several inches long. The veins are mostly parallel to the front and back surfaces (Figure 6), but portions of the veins intersect these surfaces and produce random dark mottling of the beige-gray stone. The gray veins do not absorb water more rapidly than the surrounding stone.

Figure 6. Oblique view of Slab 3 showing the sub-parallel orientation of gray veins in the beige-gray dolomitic limestone. The surface was moistened prior to being photographed to accentuate the contrast between the veins and the host limestone.

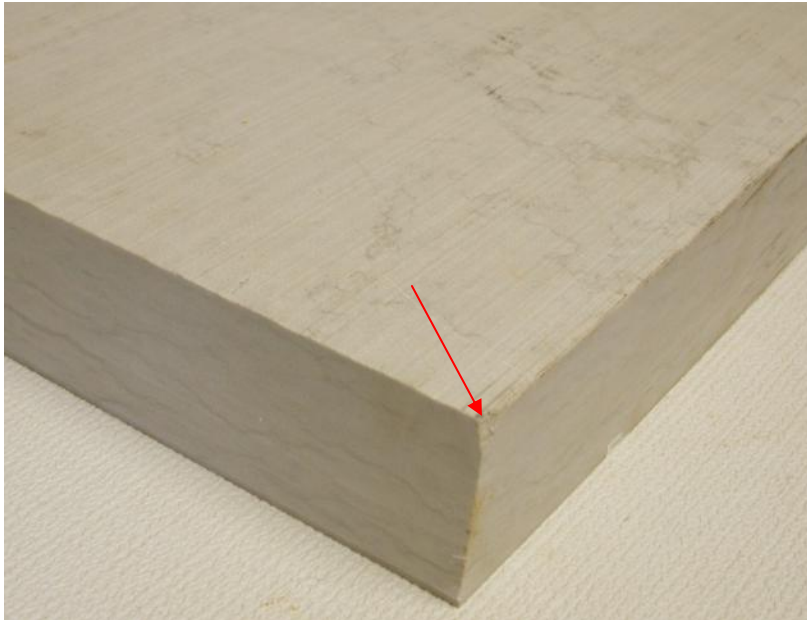
Stone represented by the slabs were previously examined and described. The stone is beige to beige-gray, fine-grained dolomitic limestone that exhibits fine-scale porosity and contains gray veining that is mostly parallel to the front and back surfaces. Portions of the veins intersect the surfaces and produce random dark mottling of the beige-gray stone. The stone does not contain prominent bedding planes. No fractures, veins, or stylolites were observed. No vugs or cavities were observed. Slab 3 had been chipped in one location along the back edge prior to initial examination. At the conclusion of testing, chips were observed at slab corners of Slabs 1 and 3. These features appear to represent damage incurred during handling.

Figure 6. Slab 1 - Oblique view of corner showing minor chip (arrow) attributed to handling damage.

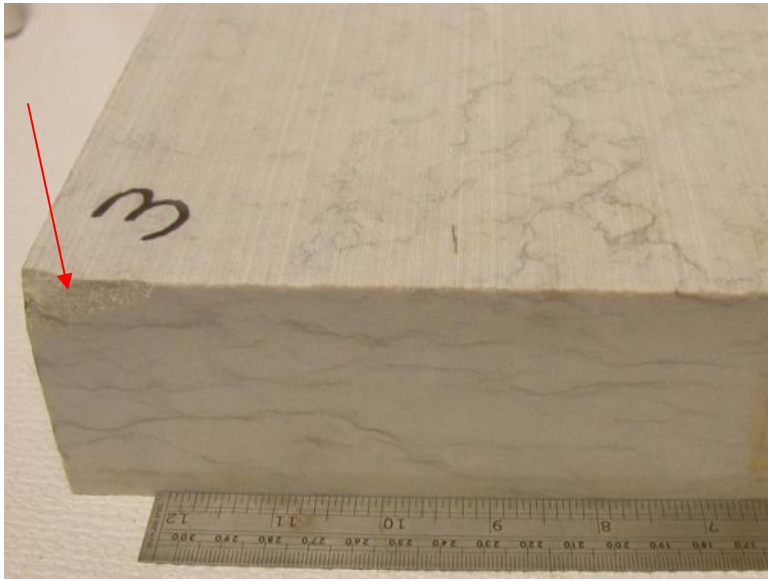
Figure 7. Slab 3 - Oblique view of corner showing minor chip (arrow) attributed to handling damage.
